## Image Report

Vandalism

123 ABC St, Columbia Heights, MN,  
USA

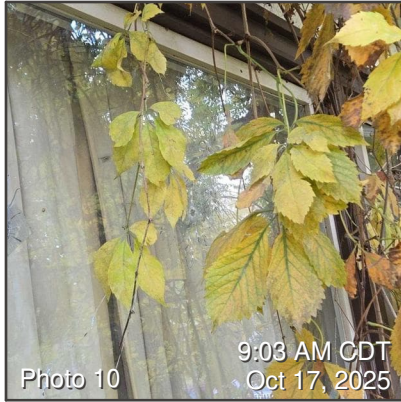
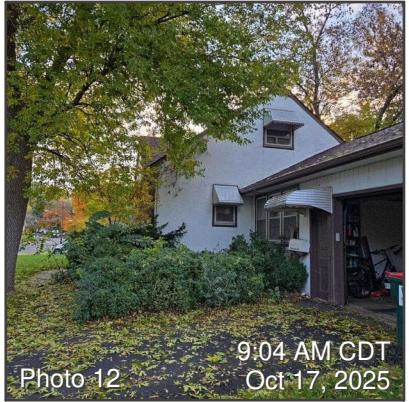
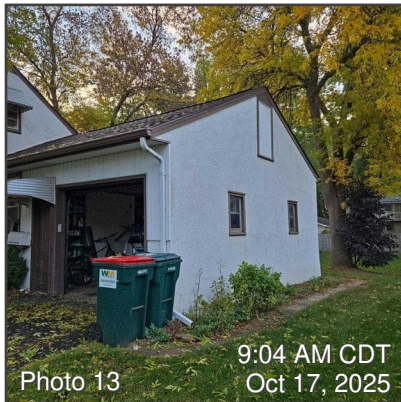
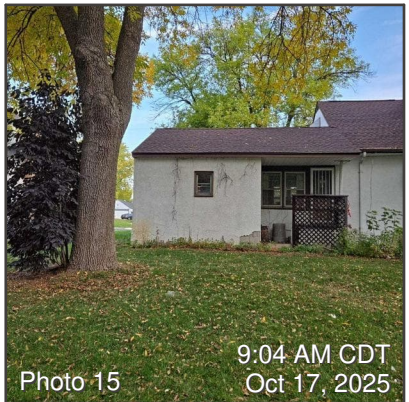
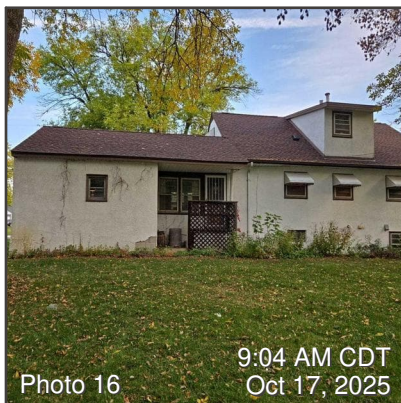
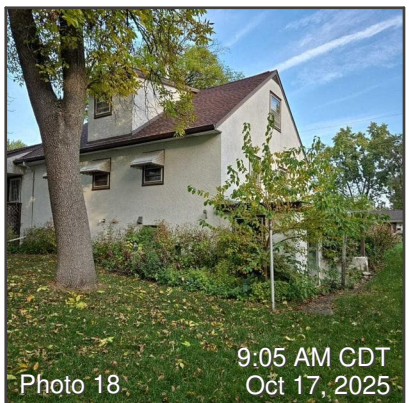
I took images of all elevations but only observed damage to the front.

Bullets through:

Front Door

2 hits to the stucco siding between the front door and window and one hit to the Upper left of the window

Window and glass had multiple hits.

Aluminum Siding

and Fascia

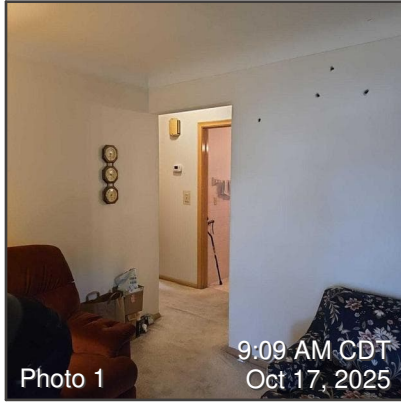
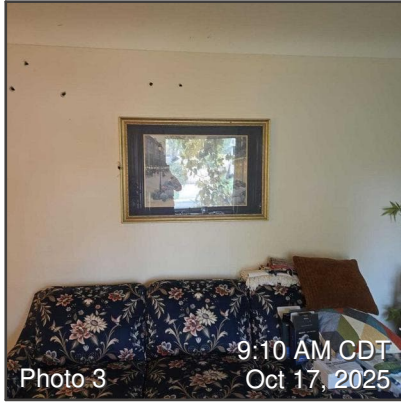
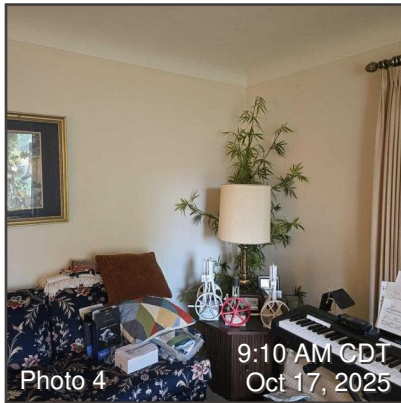
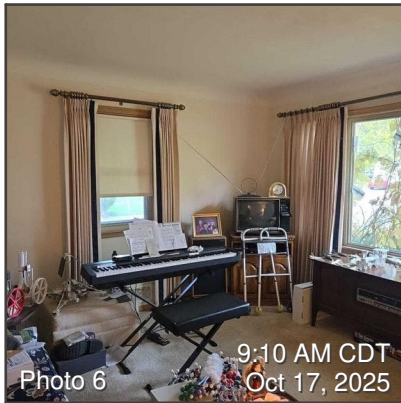
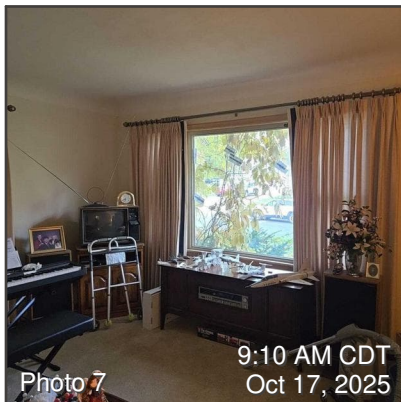
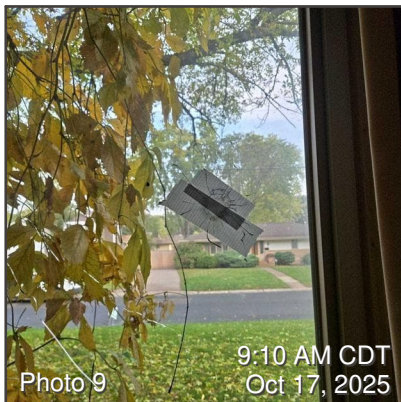
Scope
7 patches on drywall
1 damaged picture frame
Curtains damaged
Glass on carpet continuous to the hallway
Content manipulation 1-2 hours

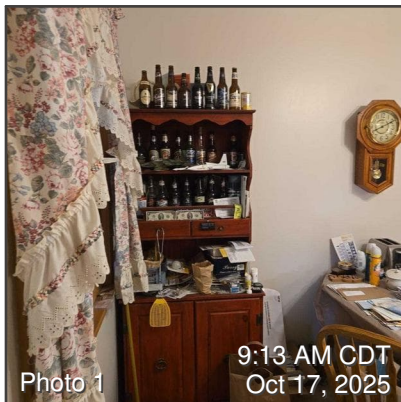
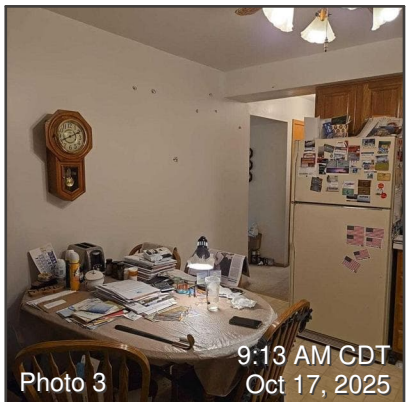
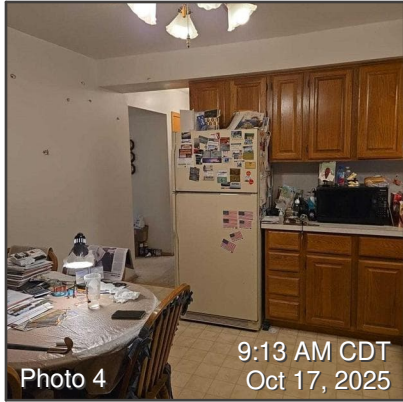
Scope
Damage to cabinets
9 drywall patches
Paint room
content manipulation 2 hours

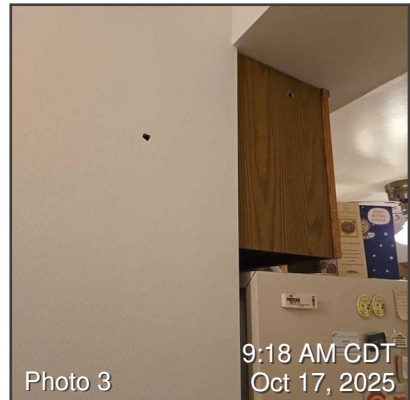
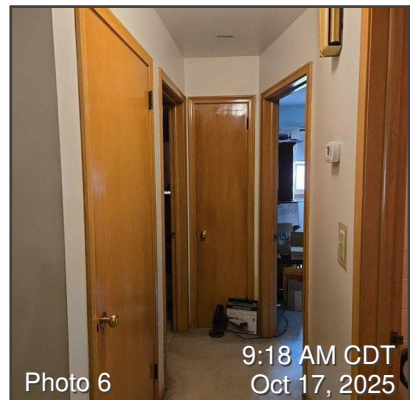
Scope
Dry patch job
Paint room

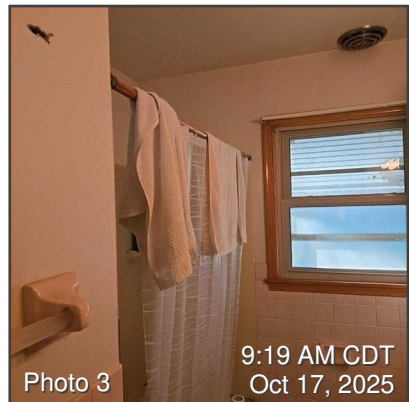
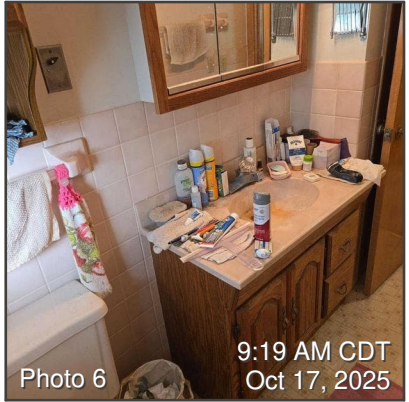
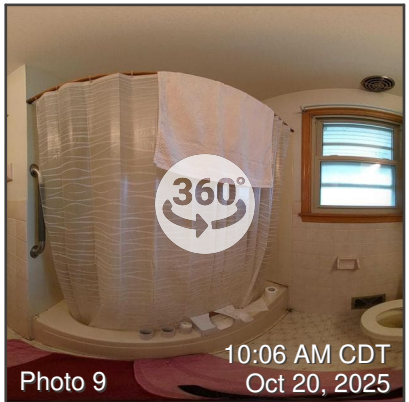
Drywall patch  
paint  
content manipulation
