## Image Report

Vandalism

123 ABC St, Columbia Heights, MN,  
USA

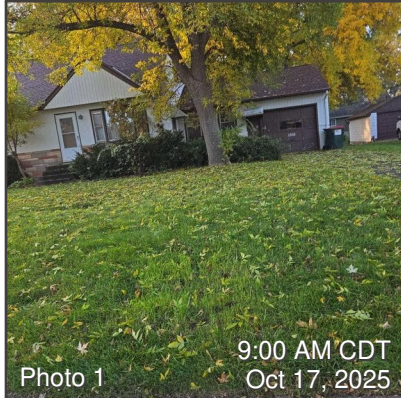
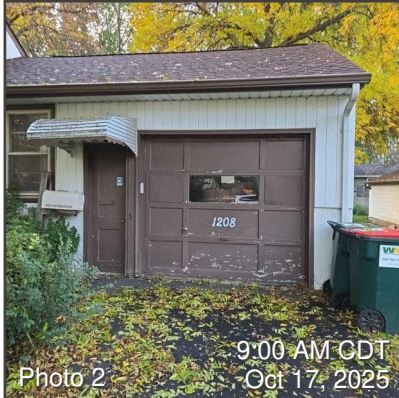
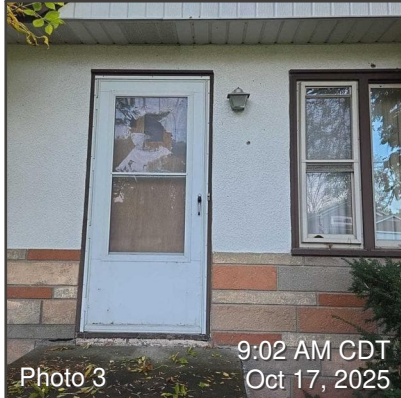
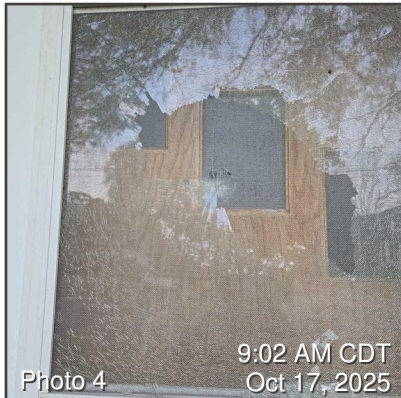
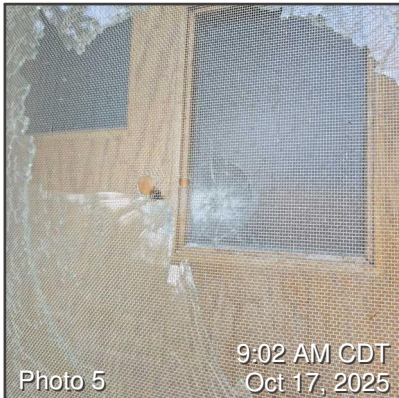
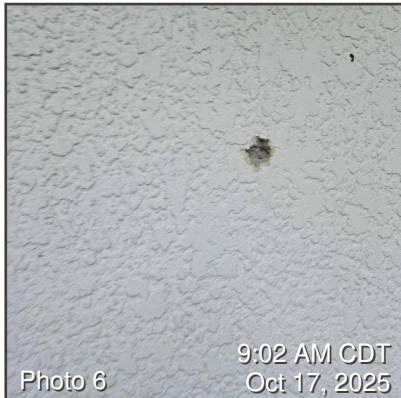
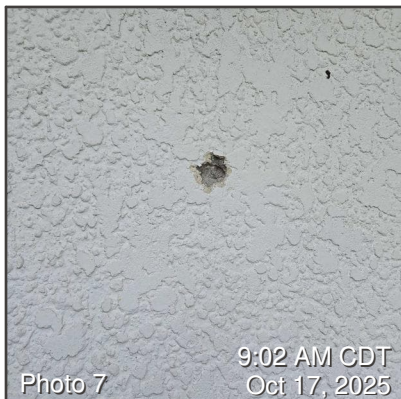
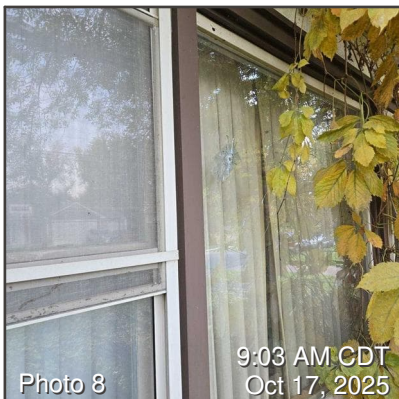
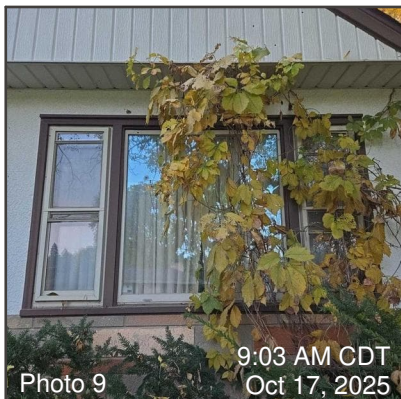
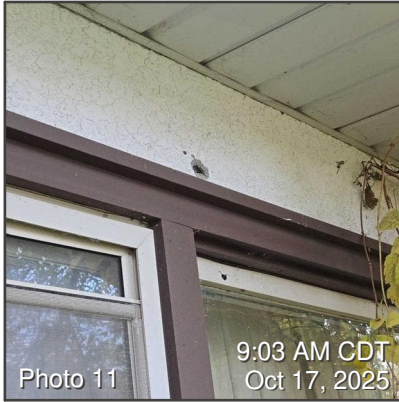
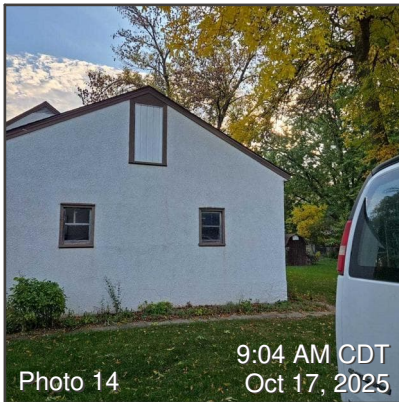
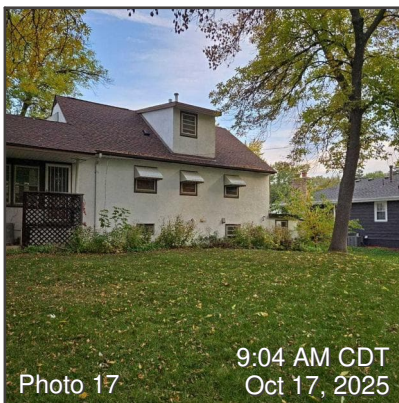
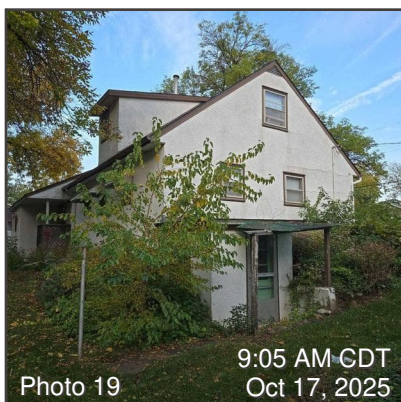
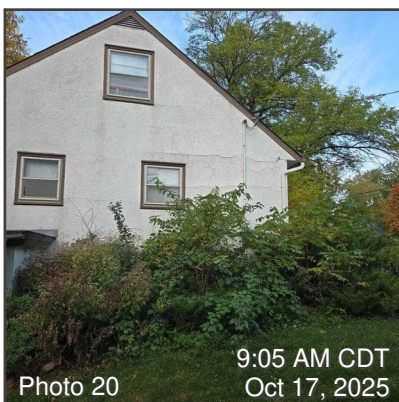
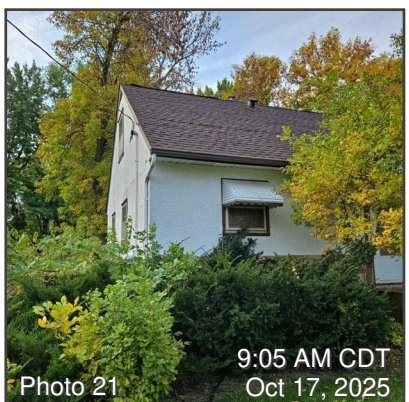
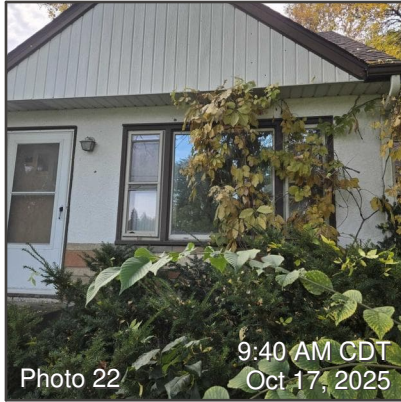
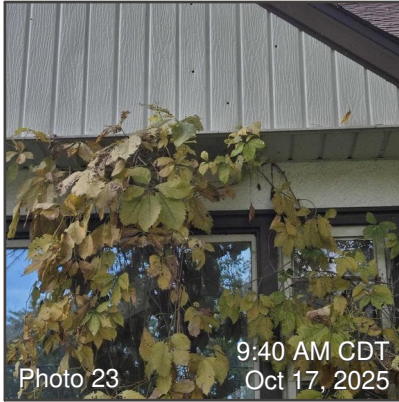
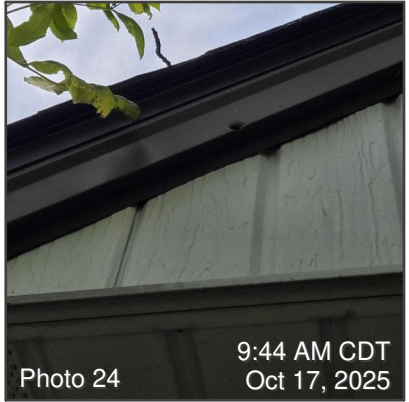
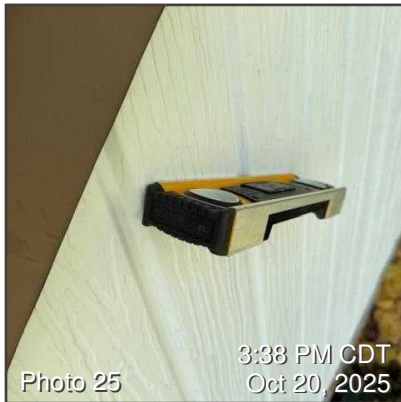
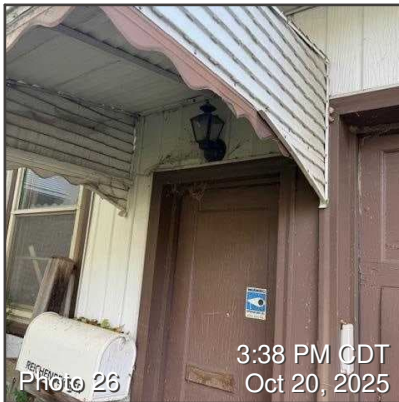
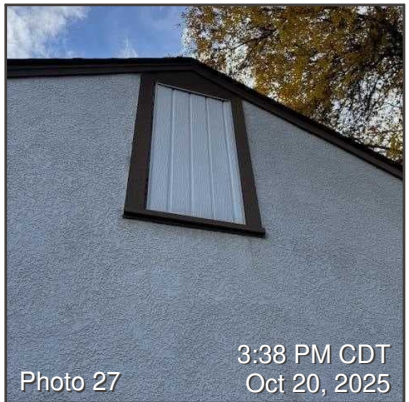
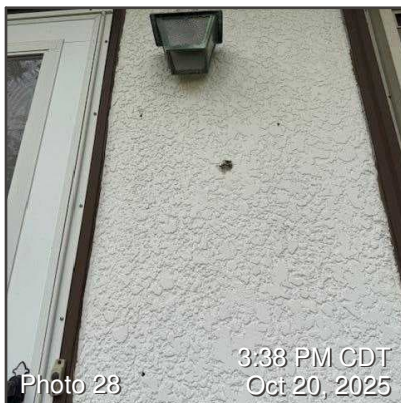
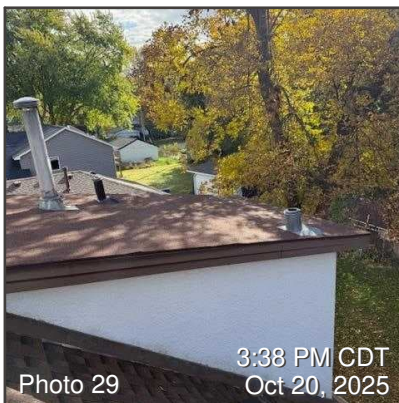
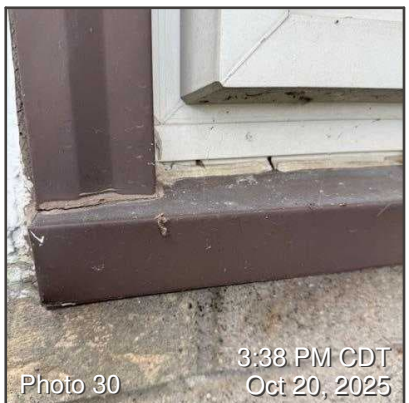
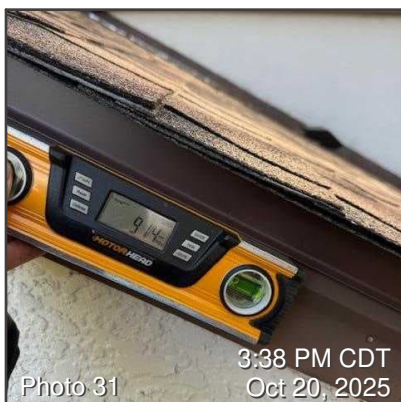
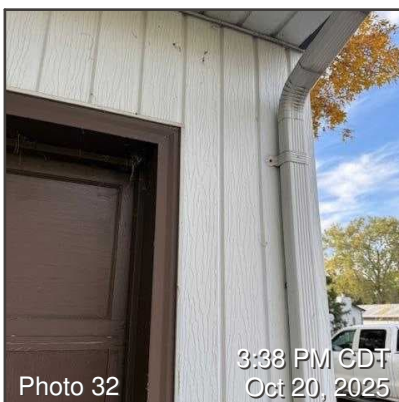
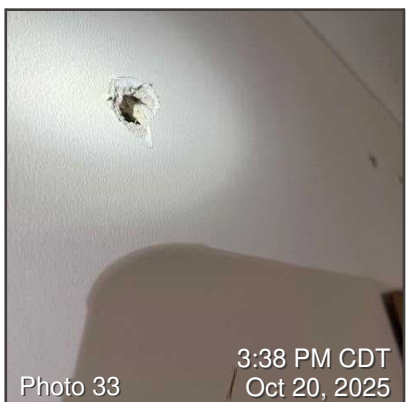
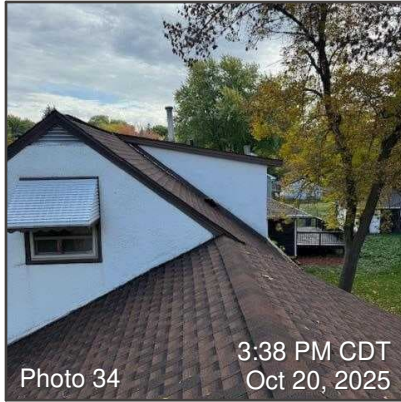
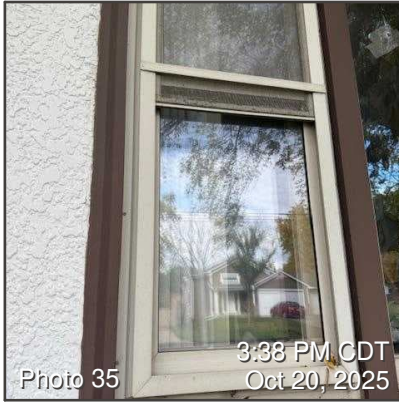
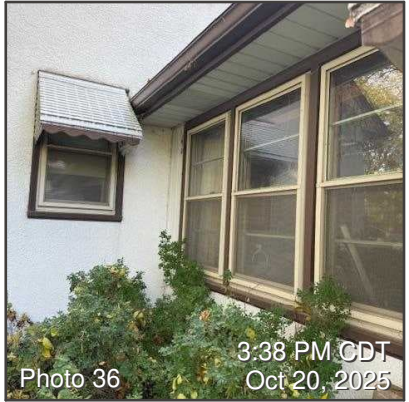
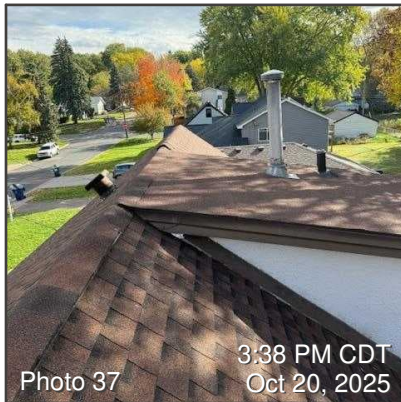
I took images of all elevations but only observed damage to the front.

Bullets through:

Front Door

2 hits to the stucco siding between the front door and window and one hit to the Upper left of the window

Window and glass had multiple hits.

Aluminum Siding

and Fascia

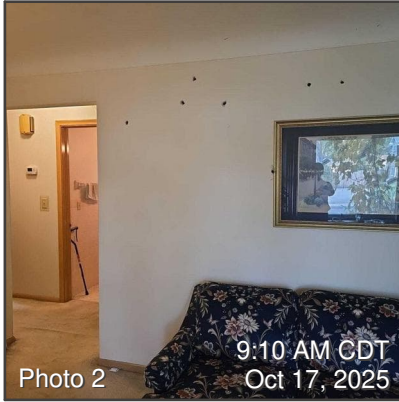
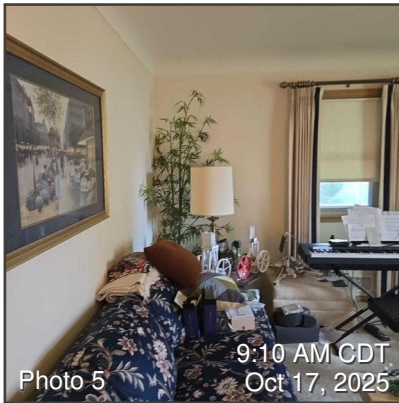
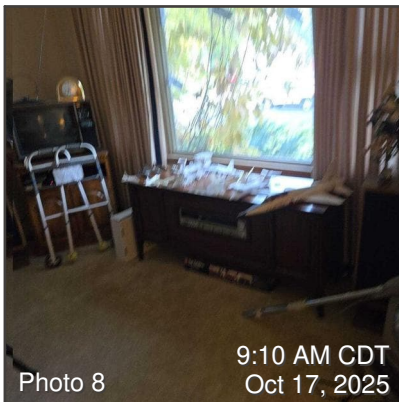
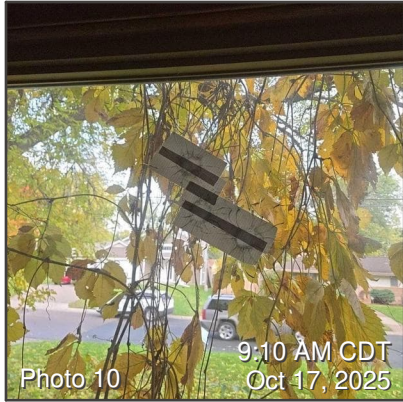
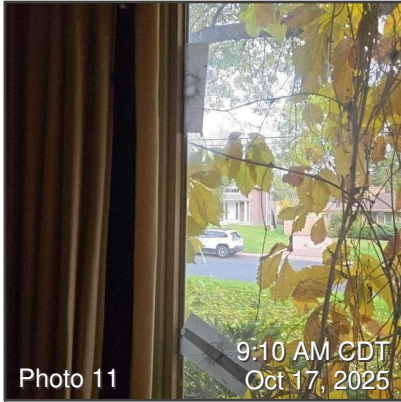
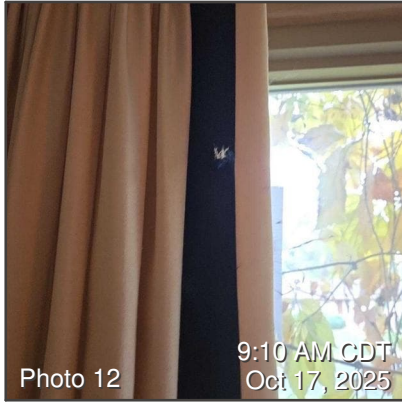
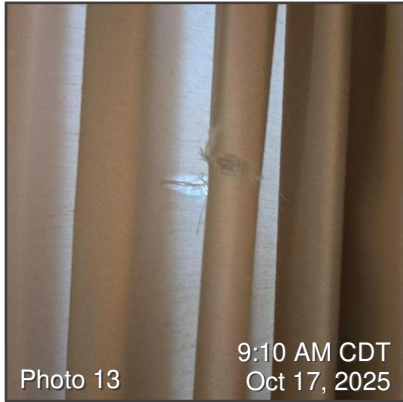
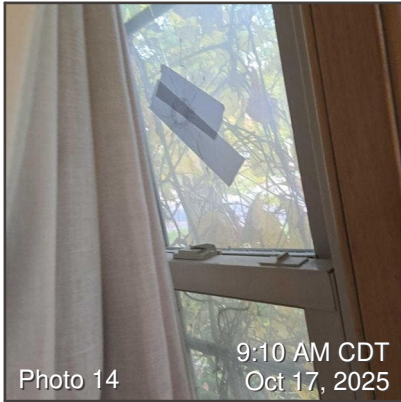
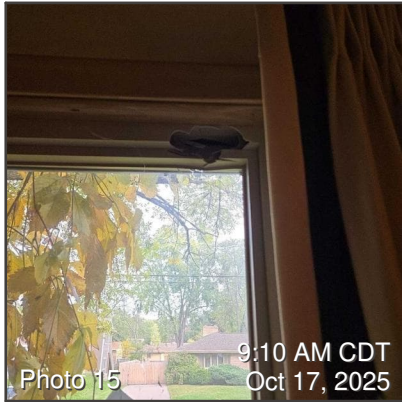
Scope
7 patches on drywall
1 damaged picture frame
Curtains damaged
Glass on carpet continuous to the hallway
Content manipulation 1-2 hours

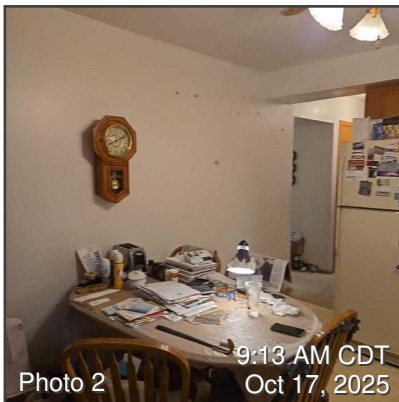
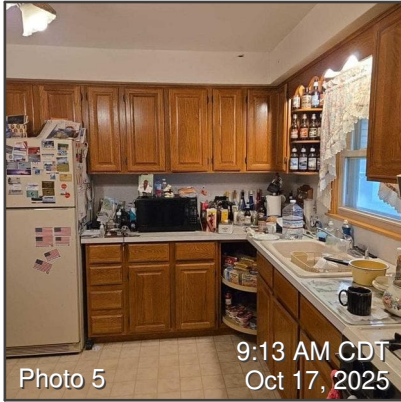
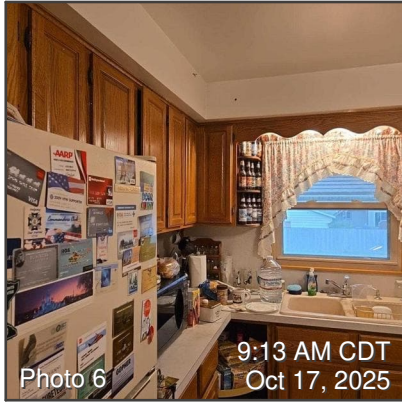
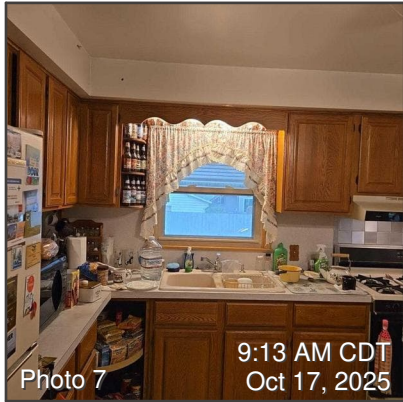
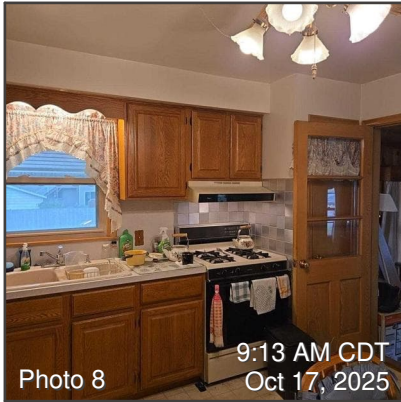
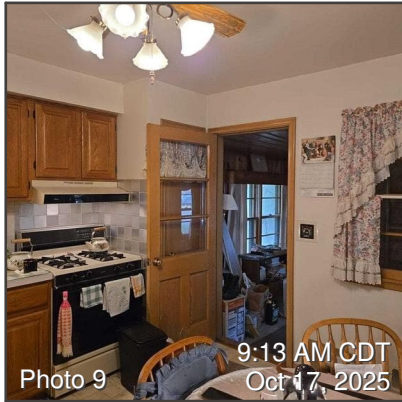
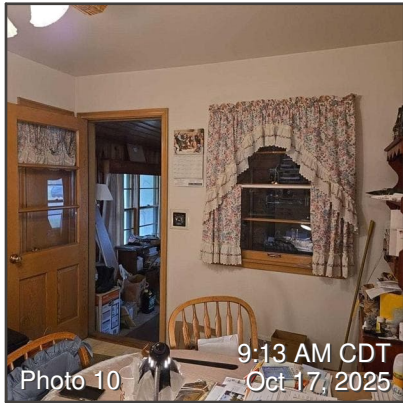
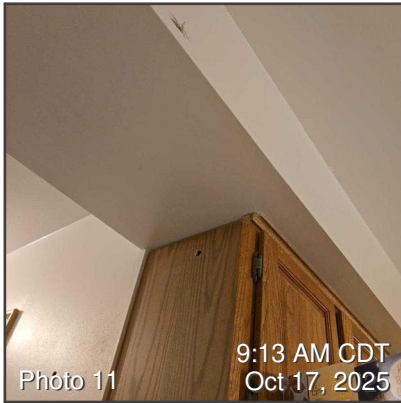
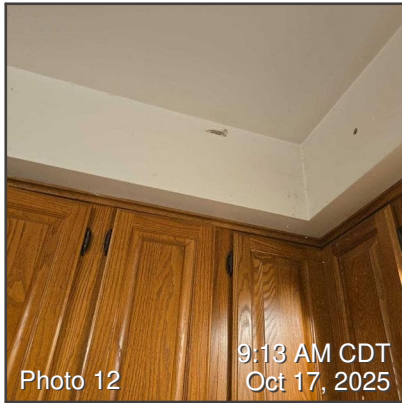
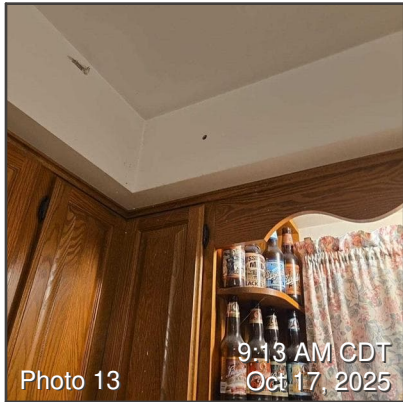
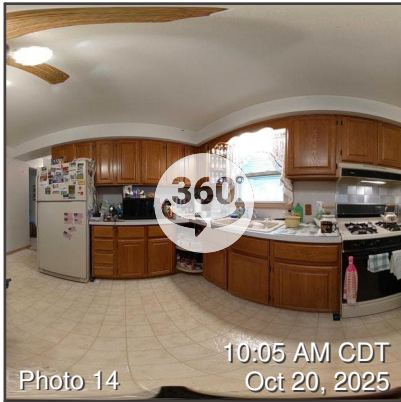
Scope
Damage to cabinets
9 drywall patches
Paint room
content manipulation 2 hours

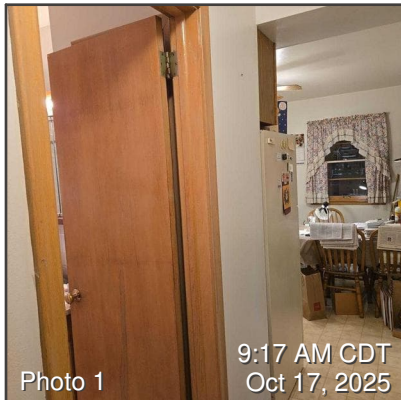
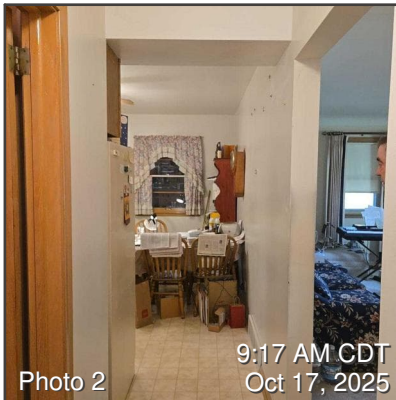
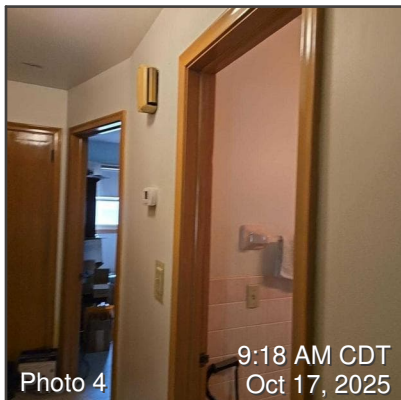
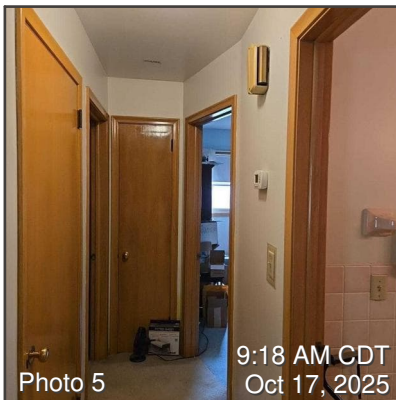
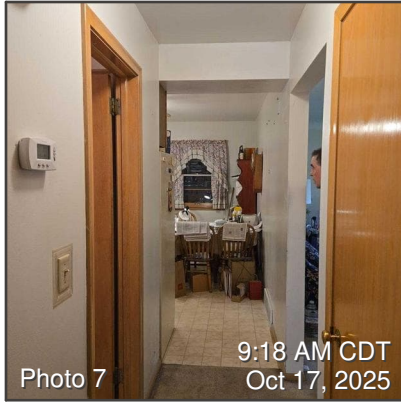
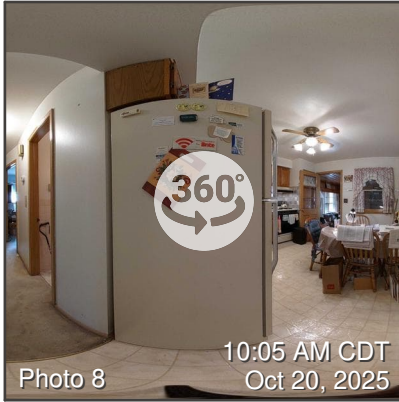
Scope
Dry patch job
Paint room
